RELIABLE LEAK DETECTION IN INDUSTRIAL GAS PRESSURE-RELIEF STATIONS

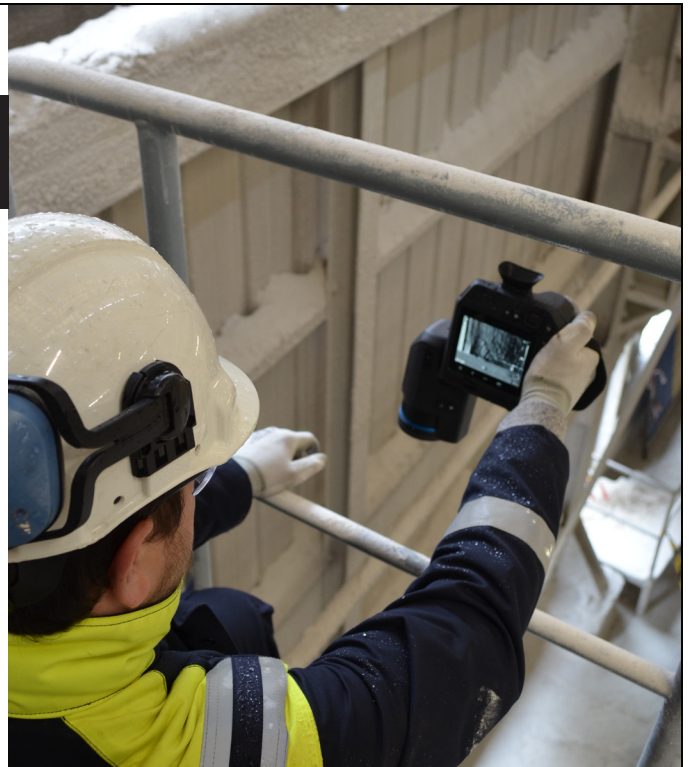
"The GF77 rotating optical block makes it easier to inspect areas that are high up or difficult to reach," said Jan Van Hout with The Sniffers

"The rotating optical block also makes it easier to inspect areas that are high up or difficult to reach," said Van Hout. When using an OGI camera ergonomically made for every job, like the GF77 from FLIR, an operator can easily inspect over railing and underneath components without strain or uncomfortable positioning.

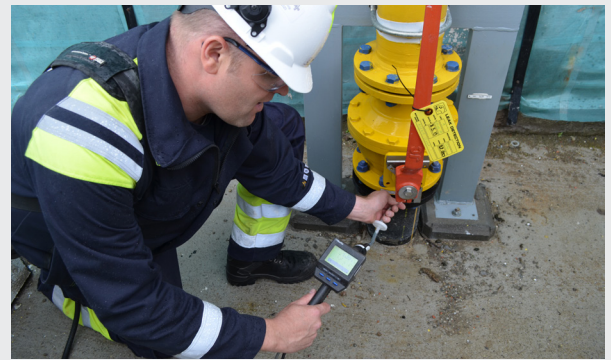
Close, contact-based inspections, like those performed with an FID, can be time-intensive and can create safety hazards as the operator is often in the gas leak when locating the faulty component.

An FID or other contact-based device requires the inspector to carefully hold the sensor very close to the leak source. This can be a time-intensive task, especially when potential leaking sources start to run into several hundreds. But this can also cause a safety hazard, having to be close to or even inside the gas cloud to identify the leak. Optical gas imaging cameras allow inspectors to scan for leaks from a distance without the need for an aerial platform.

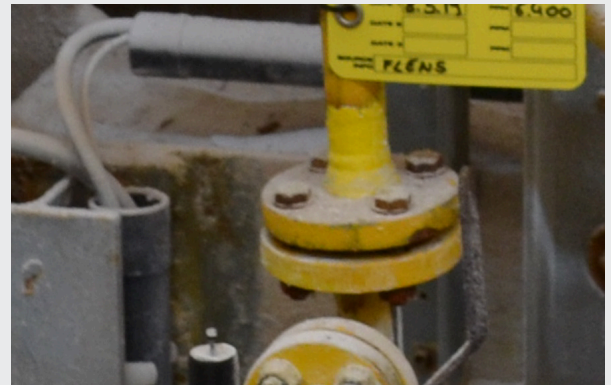
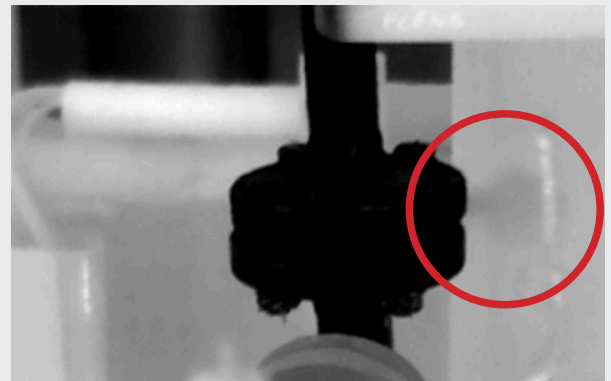
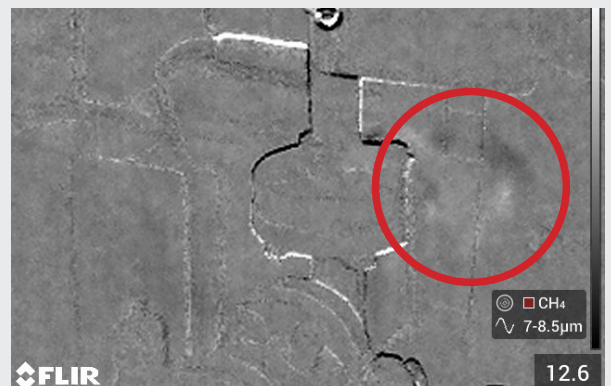
A methane leak detected with the FLIR GF77 (visual mode – IR mode – HSM mode)

Just like the cooled cameras in the GF-Series, the GF77 has three imaging modes: IR, visual, and the FLIR proprietary High Sensitivity Mode (HSM), which accentuates plume movement to make tiny gas leaks more visible.

During a thorough inspection of one of the pressure-relief stations, Van Hout and Schraeyen were able to find a leak at one of the connections. "The gas leak is clearly visible in the HSM image and the image quality is surprisingly good for such a compact, cost effective camera," said Van Hout.
